# UNDERWATER BRIDGE INSPECTION REPORT

STRUCTURE NO. 7274

LE SUEUR RIVER

MINNESOTA DEPARTMENT OF TRANSPORTATION  
UNDERWATER BRIDGE INSPECTION

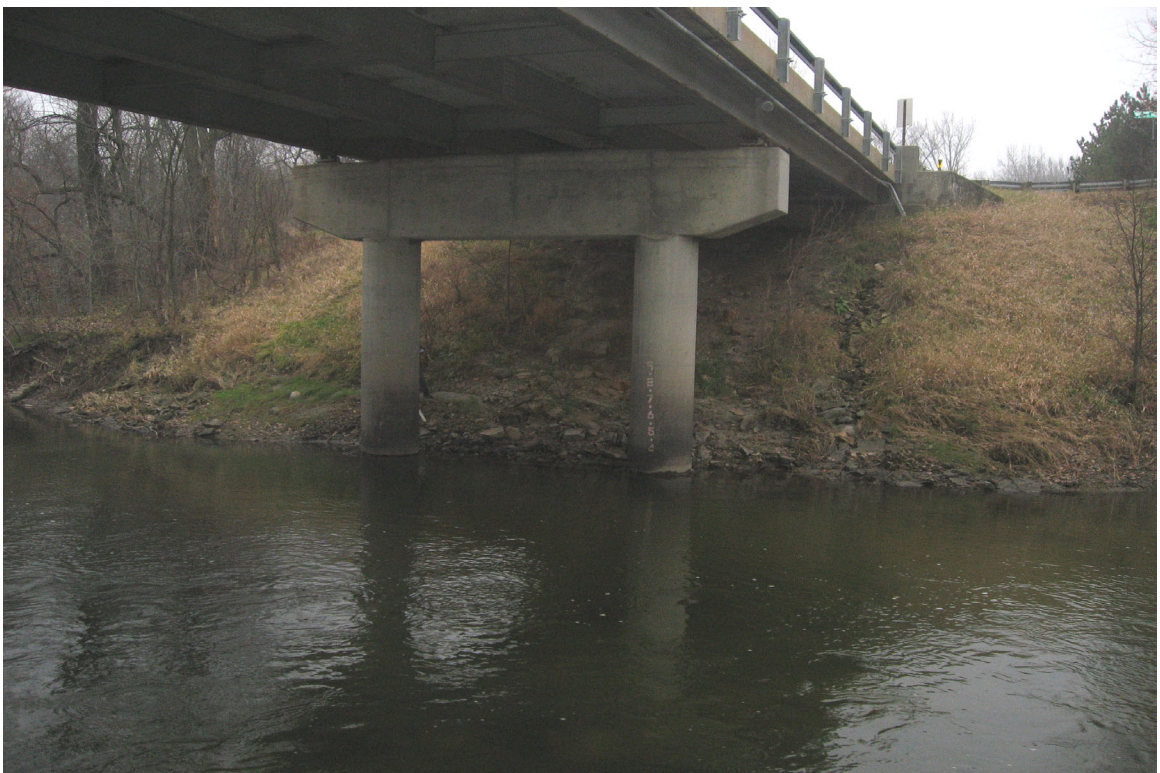
Photograph 2. View of Pier 1, Looking South.

- 6 The top of the diaphragm was exposed along the north face of Pier 1 with up to 2.2 feet of vertical face exposure at the upstream end.

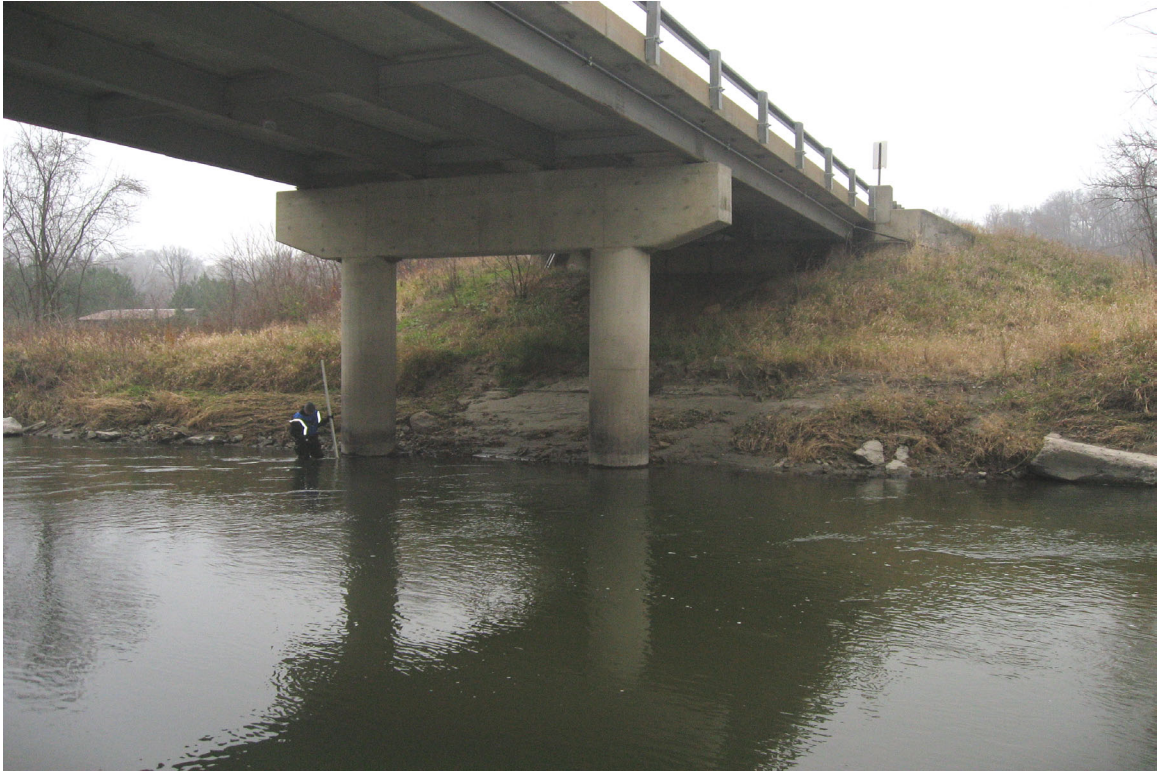
Photograph 3. View of Pier 2, Looking Northwest.

- 4 The top of the diaphragm was exposed along the south face of Pier 2 with up to 2.1 feet of vertical face exposure at the upstream end and there was heavy section loss with exposed aggregate and reinforcing steel along the entire exposed portion. Up to 1 foot of penetration was present for the section loss (upstream column mainly).

- 5 Two horizontal steel reinforcing bars were completely exposed and were no longer embedded in the concrete diaphragm and four vertical bars were exposed at the diaphragm of upstream column of Pier 2.

Ideally, the deteriorated concrete of the diaphragm at Pier 2 should be repaired by removing the unsound concrete and reforming with a concrete mix designed to promote high durability and low permeability. Continue to monitor the diaphragm deformation until repairs are accomplished.

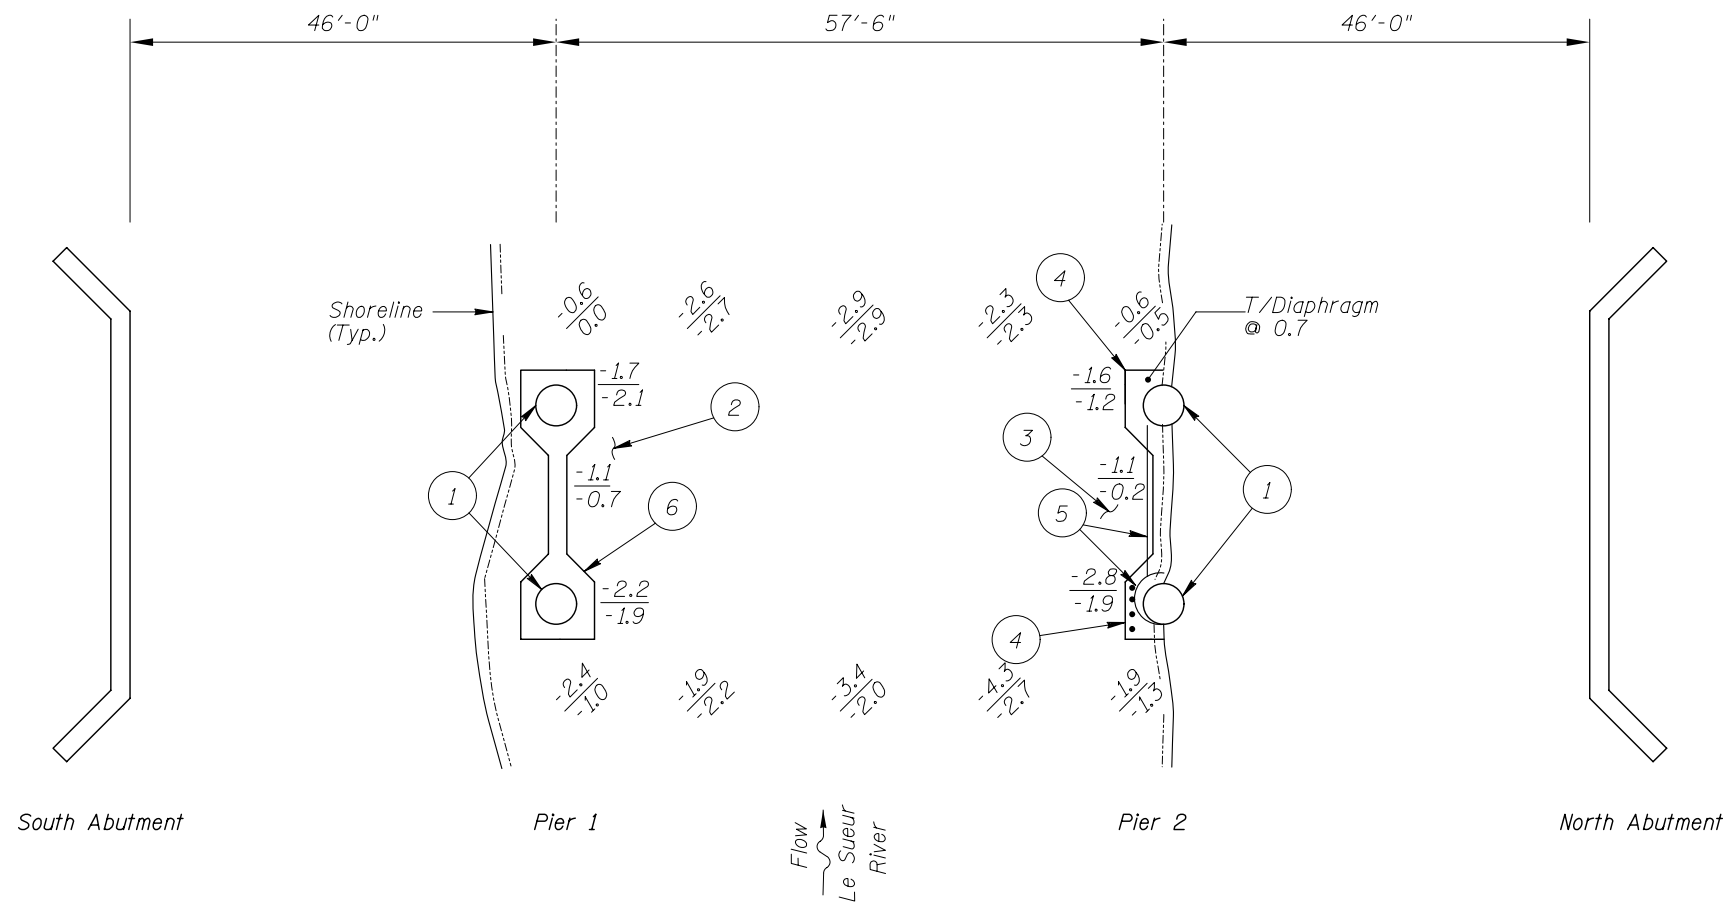
**INSPECTION AND SOUNDING PLAN**

- 1 Overall, the concrete columns were in good and sound condition.
- 2 The channel bottom at Pier 1 consisted of riprap with no probe rod penetration.
- 3 The channel bottom at Pier 2 consisted of sandy gravel and riprap with a probe rod penetration of 1 inch.
